**ENGINEERING STUDY OF STRUCTURAL GEOLOGIC FEATURES
OF THE HERRIN (NO. 6) COAL AND ASSOCIATED ROCK IN ILLINOIS**

Volume 1—Summary report

**UNITED STATES DEPARTMENT OF THE INTERIOR
BUREAU OF MINES**

**Illinois Institute of Natural Resources,
ILLINOIS STATE GEOLOGICAL SURVEY DIVISION, Urbana, Illinois**

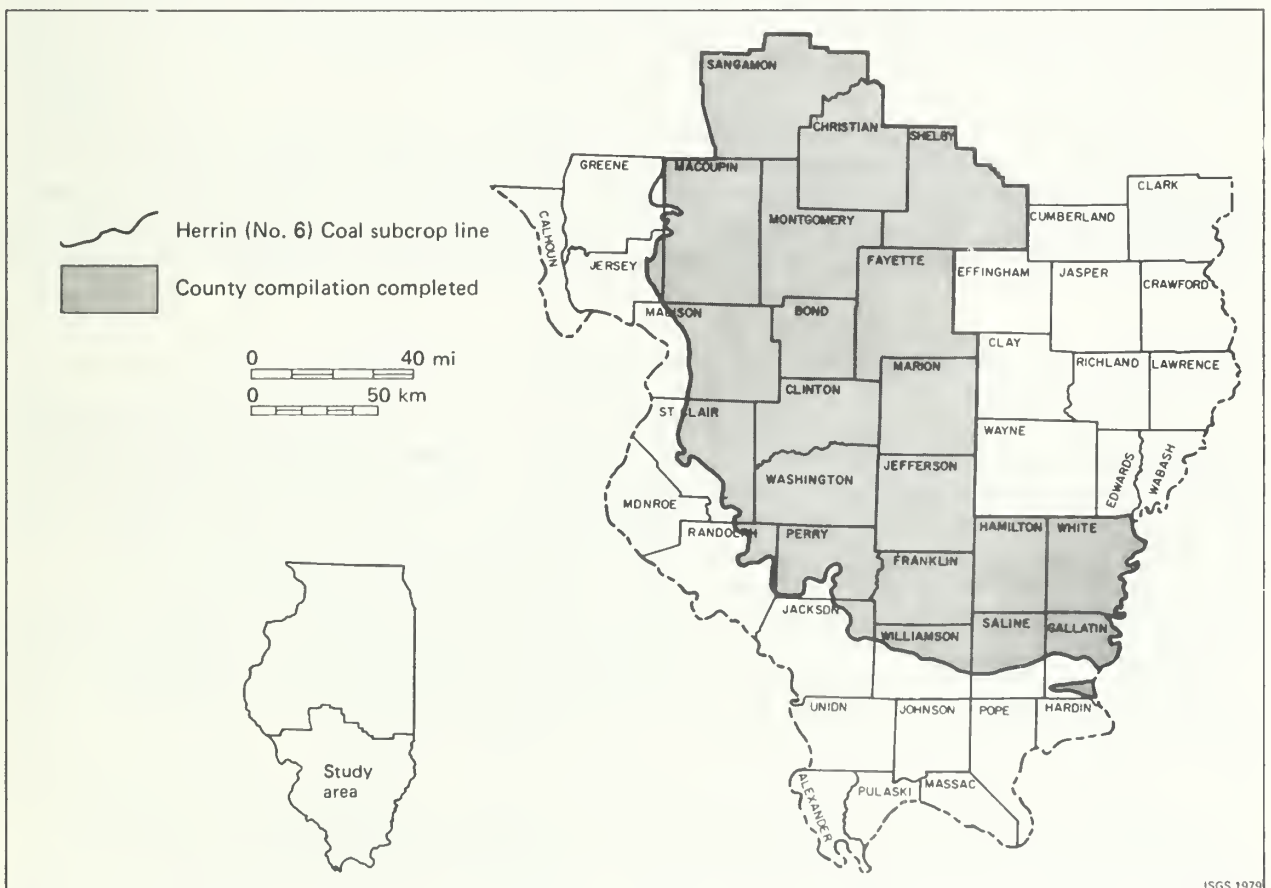
Figure 5. Area in the southern half of Illinois for which data on thickness and facies of roof strata above the Herrin (No. 6) Coal extending up to the Piasa Limestone were collected and compiled in computer-processible form.

Regional computer mapping was applied to 23 counties where reserves of the Herrin (No. 6) Coal are significantly large (fig. 5). Data on thickness and elevation were evaluated for all rock units from the Herrin (No. 6) Coal

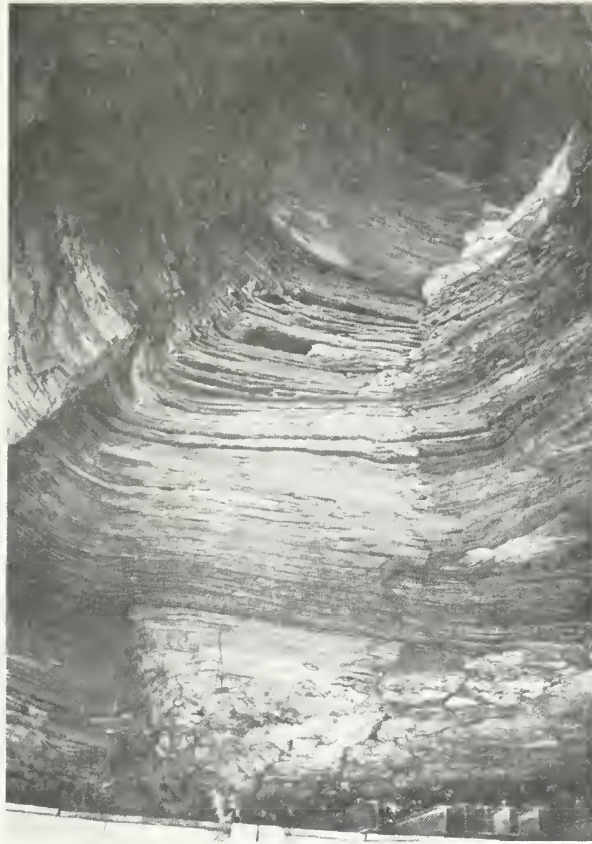
Figure 6. Roof fall in planar-bedded sandstone of the Energy Shale Member. Bedding surfaces are coated with mica and coalified plant fragments. No prominent joints are visible. Sandstone failed and broke almost straight up along the pillar rib. Location: "Quality Circle," near Walshville channel, mine C.

The planar-bedded siltstone and sandstone is marked by closely spaced regular partings of coarse mica and carbonaceous plant debris on bedding surfaces. The rock easily splits and separates along those partings, and spectacular roof falls are common (fig. 6). In addition, the sandstone may contain water, which weakens the underlying medium-gray shale and promotes more falls; the seepage or flow of water into mining areas causes serious problems.

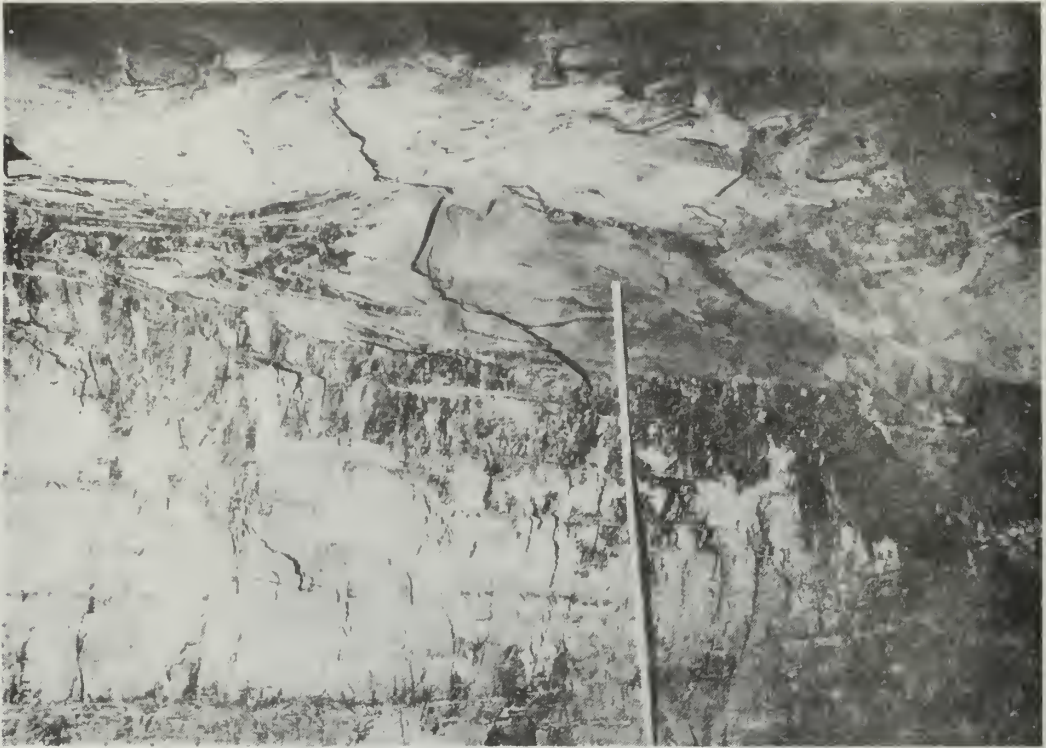
Figure 8. Roll of medium-gray shale of the Energy Shale Member intruded into top layers of the Herrin (No. 6) Coal. Toe (at the left) splits folded coal strata into several stringers. Tail has been truncated by compactional normal fault (at the right). The rod is about 4 feet (1.2 m) long. Location: "Quality Circle."

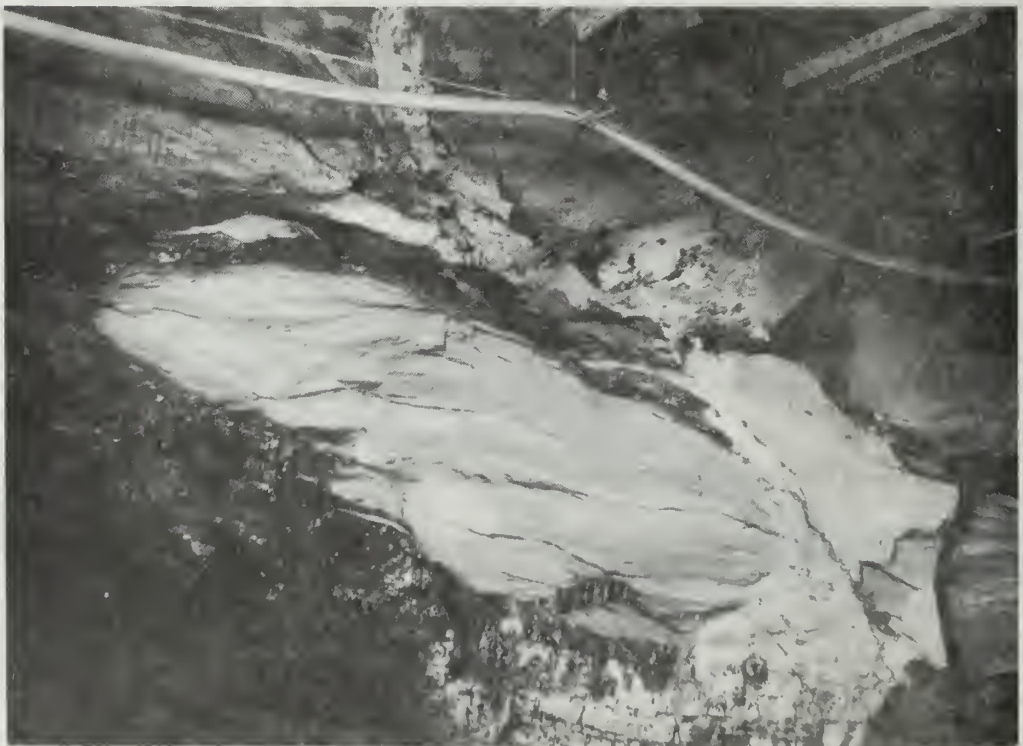
Figure 9. Large roll (10 feet [3 m] wide) of siltstone material. The toe of the roll displays slight soft-sediment deformation. Coal "rider" extends over two-thirds of the roll. Location: "Quality Circle," southern Illinois, mine C.

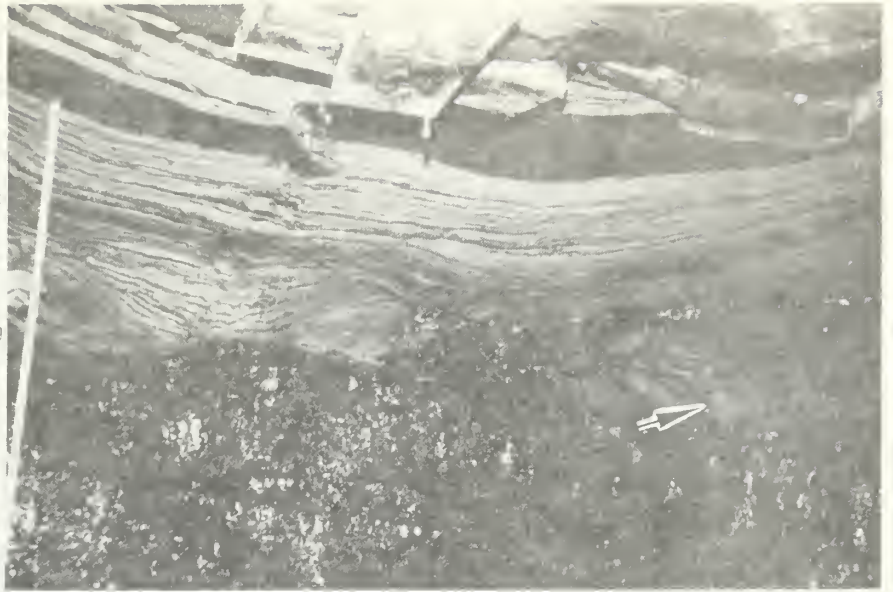
Figure 10. Roll in planar-bedded siltstone and sandstone of the Energy Shale Member. Near the toe of the roll (arrow), recumbent soft-sediment folds and low-angle shear planes are visible. These features suggest that the silt and sand filling the roll intruded from right to left between the layers of peat. (Note the coal "rider" originating at the toe and extending almost entirely over the roll.) The large low-angle slips at the tail of the rolls may have formed later by differential compaction.

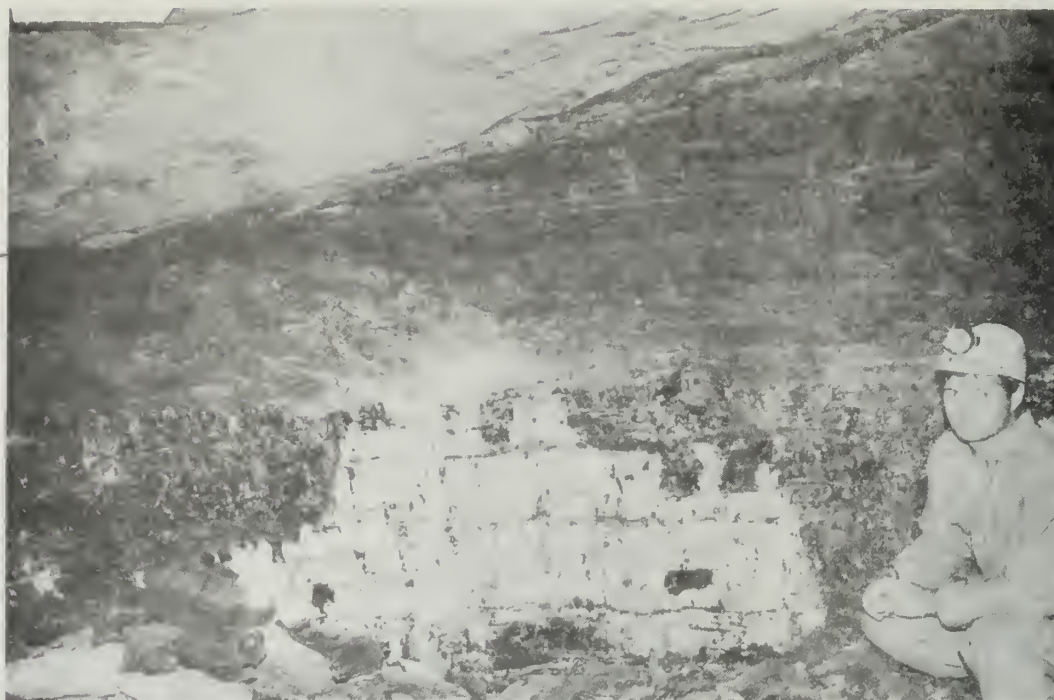
Figure 17. Almost undisturbed Herrin (No. 6) Coal and some beds of finely laminated silty shale truncated by a northward-dipping (to the left) set of major shear surfaces and overlain by the shear body. Location: southern Illinois, "Quality Circle," study area 5, mine B.

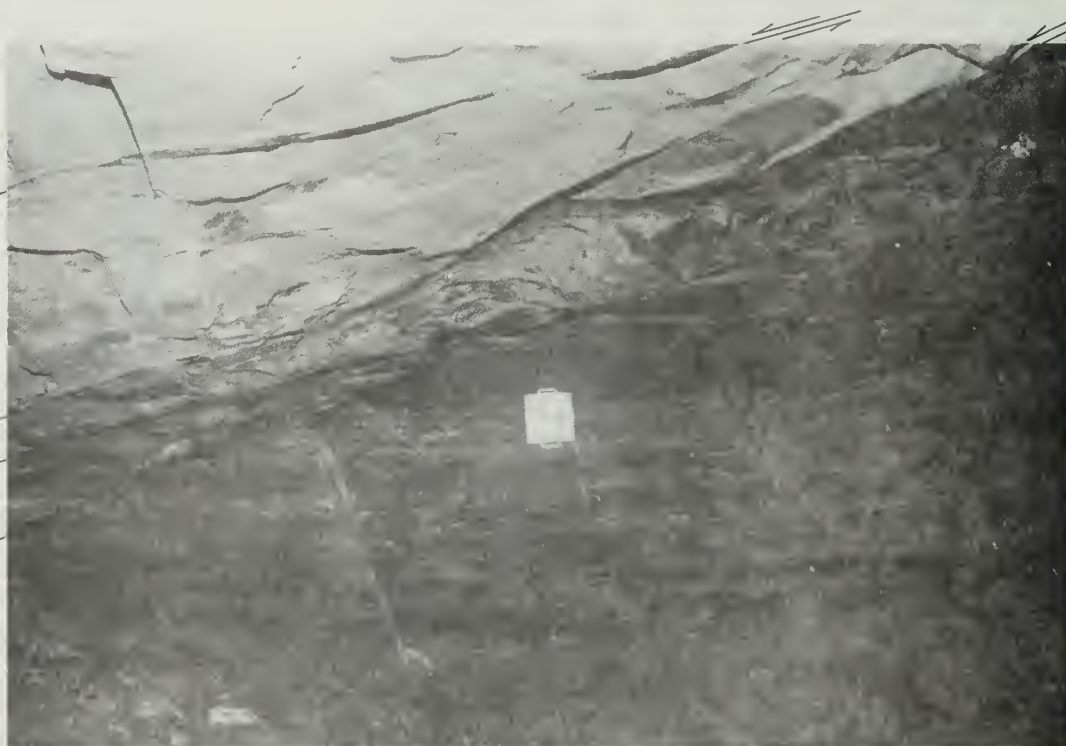
Figure 18. Detail of figure 17—major shear surfaces, a set of very low-angle normal faults bordering the shear body (light rock, upper part of photo) and truncating finely laminated shale below. Note the associated drag folds (soft-sediment folds above compass) within the shear zone.

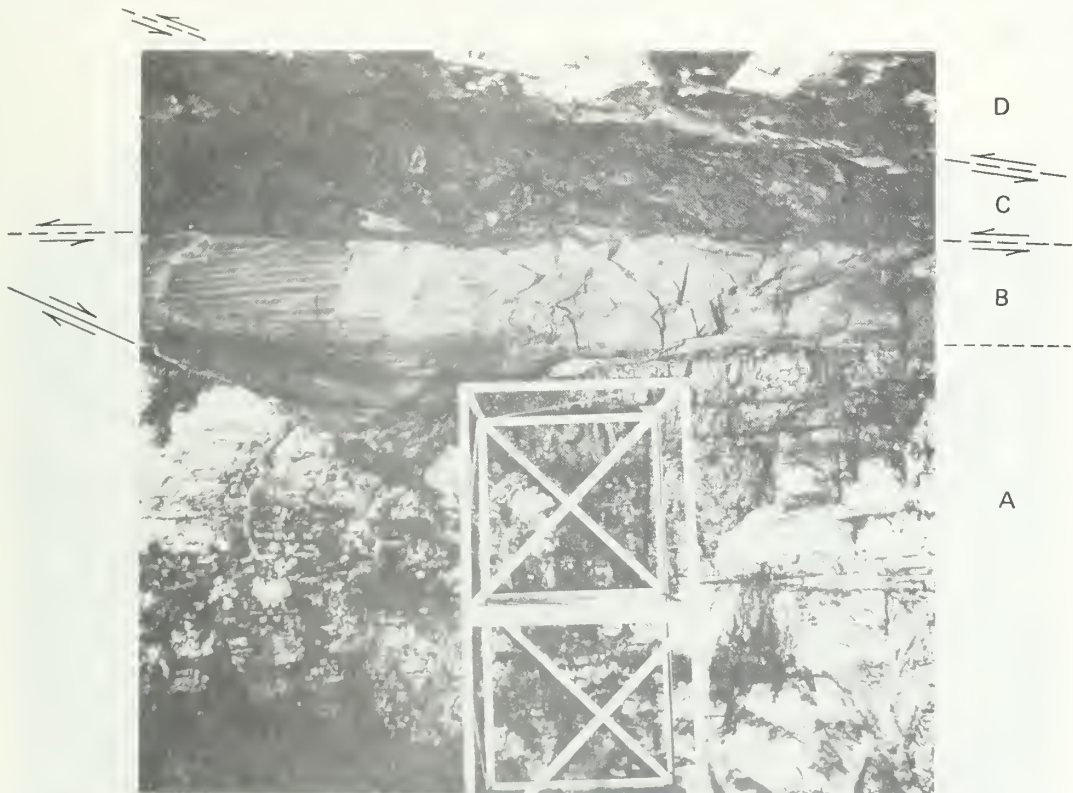
Figure 19. Nearly horizontal shear zone of a set of shear surfaces enclosing dragged, folded, and sheared dark-gray shale; main shear movement of each upper shear bed is toward the left and has truncated the top of a major roll of silty medium-gray shale. This indicates that formation of shear body continues after or even postdates formation of rolls; however, small low-angle antithetic faults truncate shear zone of dark-gray shale and remnant of rolls, so these postdate both roll and shear zone. Section from bottom of photo to top: (A) coal slightly deformed by fault in roll (left side of photo), (B) laminated silty shale within the roll, (C) folded, sheared, and intensely contorted dark-gray shale in shear zone, and (D) greenish claystone of main shear body. Scale: holes in aluminum frame are one foot (30.5 cm) apart. Location: southern Illinois, "Quality Circle," study area 5, mine B.

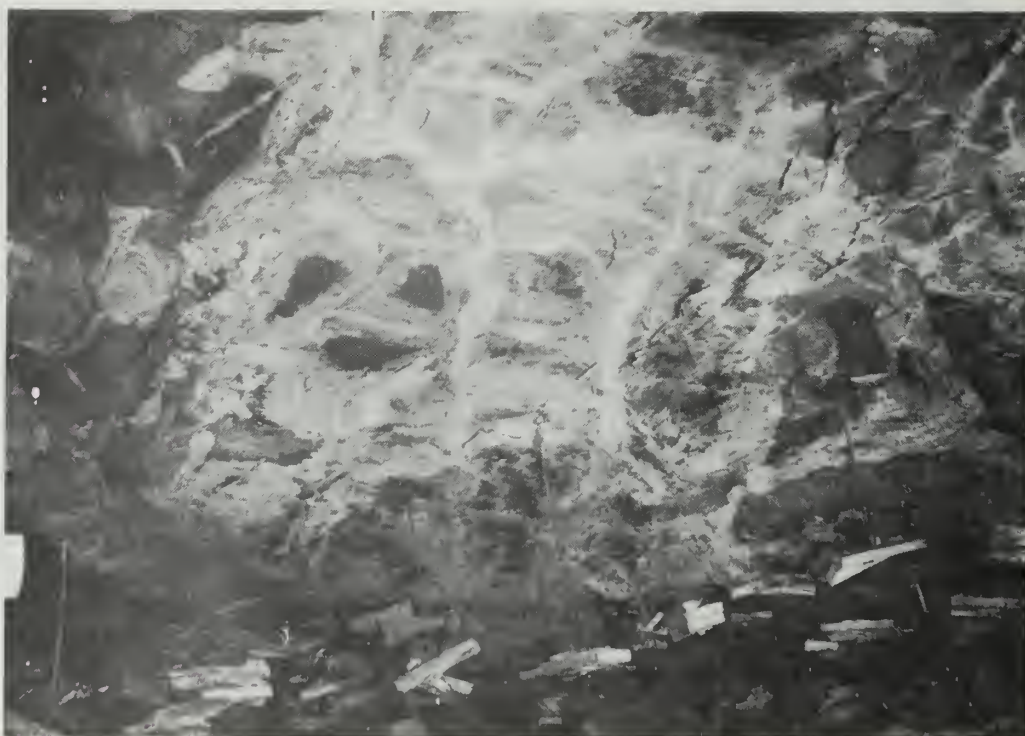
Figure 29. Mottled shale with syneresis cracks in greenish medium-gray shale, above very dark gray shale, probably Lawson Shale (with syneresis cracks) above Anna Shale. Note roof bolts hang out bare; the soft shales have fallen because of moisture slaking; in the center of roof fall, even bolt anchors have fallen out. Location: a mine in east-central Illinois.

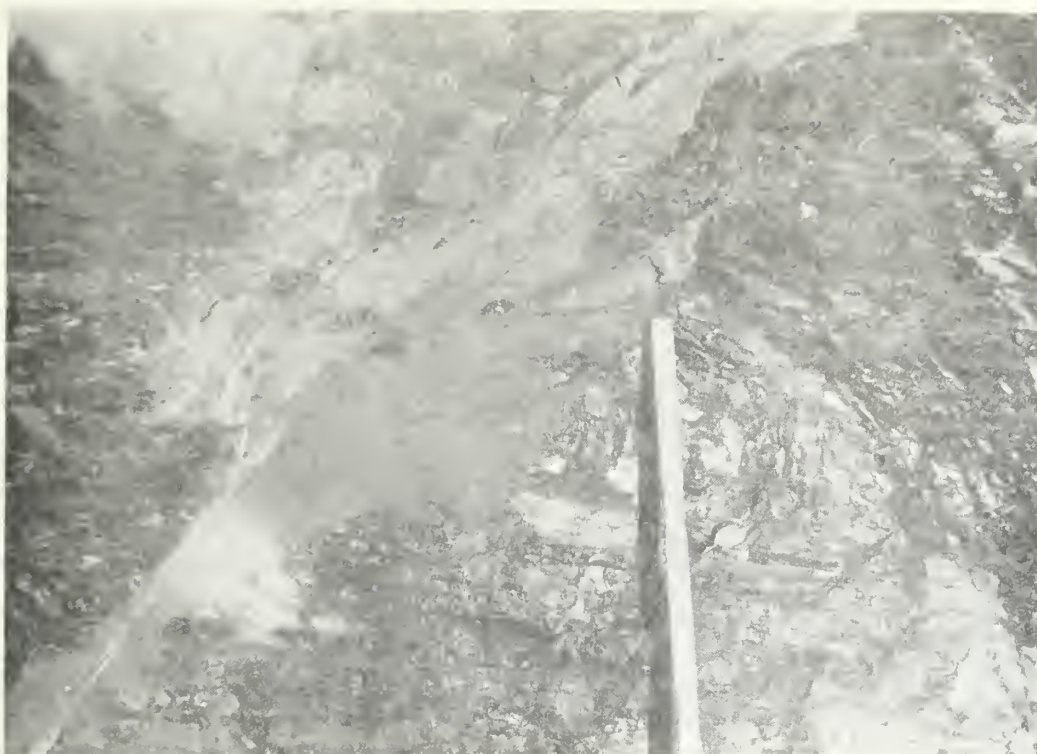
Figure 30. Clay dike and clay-dike fault in Herrin (No. 6) Coal. Angular fragments of unaltered and altered black shale from the roof and of coal in the clay matrix demonstrate the brittle behavior of the material during deformation. Synthetic and antithetic minor faults are displayed. Note also the plastic behavior of coal, particularly at the end of the small clay intrusion upward, in the upper footwall block. Displayed there is a convergence structure of the coal laminae. Location: mine A, west-central Illinois.

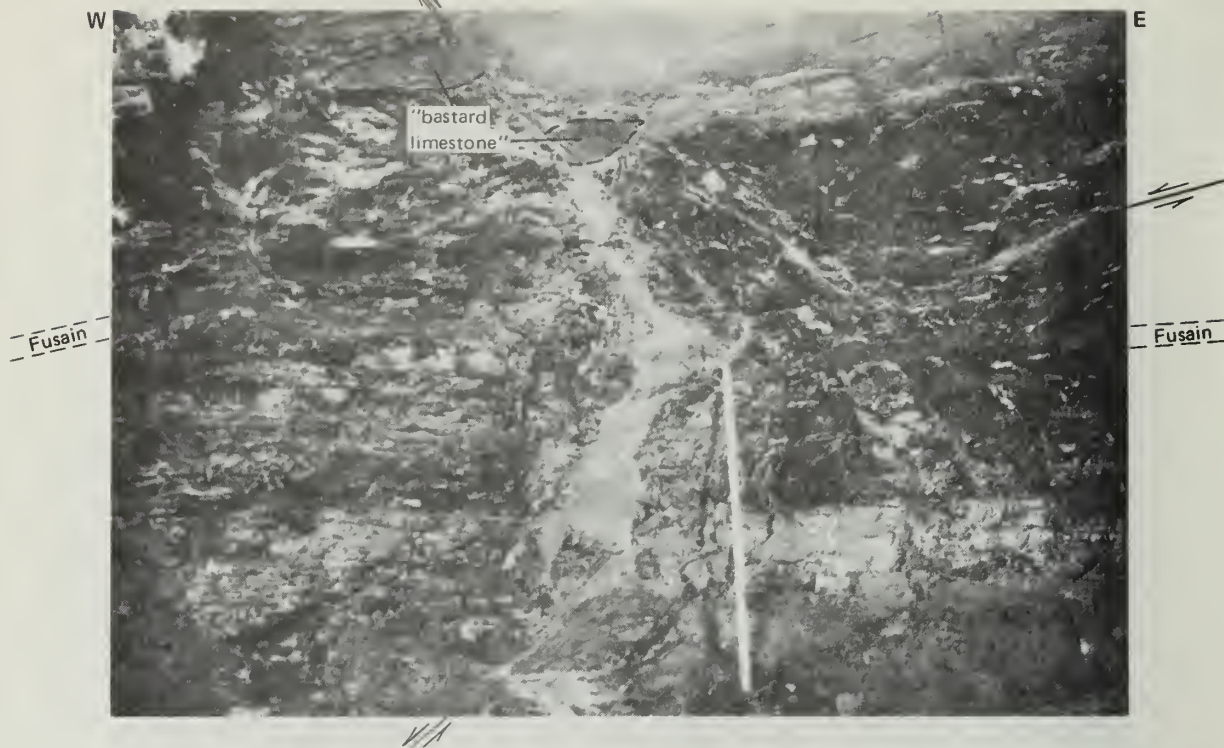
Figure 32. Complex clay dike in the Herrin (No. 6) Coal. Roof is Brereton Limestone, which is displaced downward to the east. Fusain layer in the center of the coal seam is bent downward east of clay dike, fractured within the clay dike, and offset immediately west of the dike. Note the associated small low-angle clay-dike faults and the numerous extension fractures ("goat beards") and the coal fragments in the clay matrix.

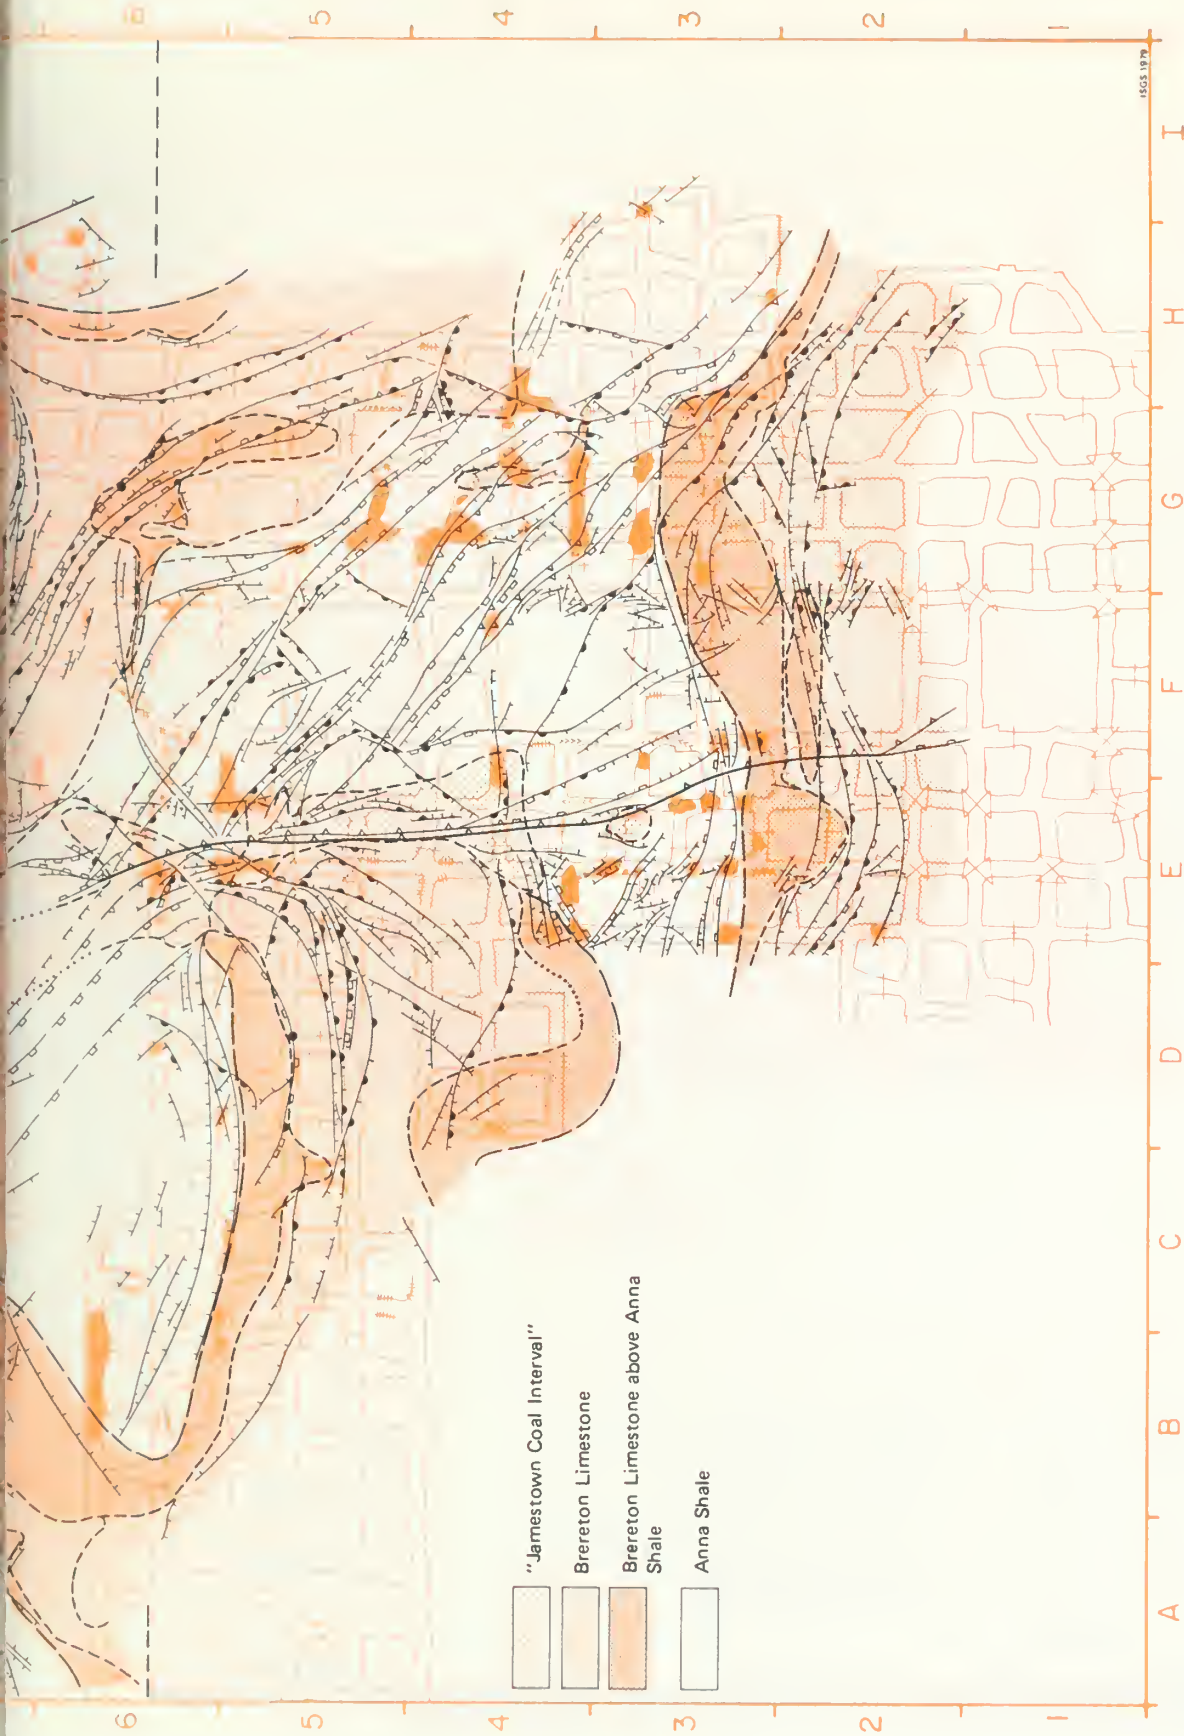
Figure B. Distribution of lithology, of clay-dike faults and clay dikes in the Herrin (No. 6) Coal and its immediate roof strata, and of roof falls and other induced instabilities in study area 2, mine A. (See also fig. 36, p. 33.)

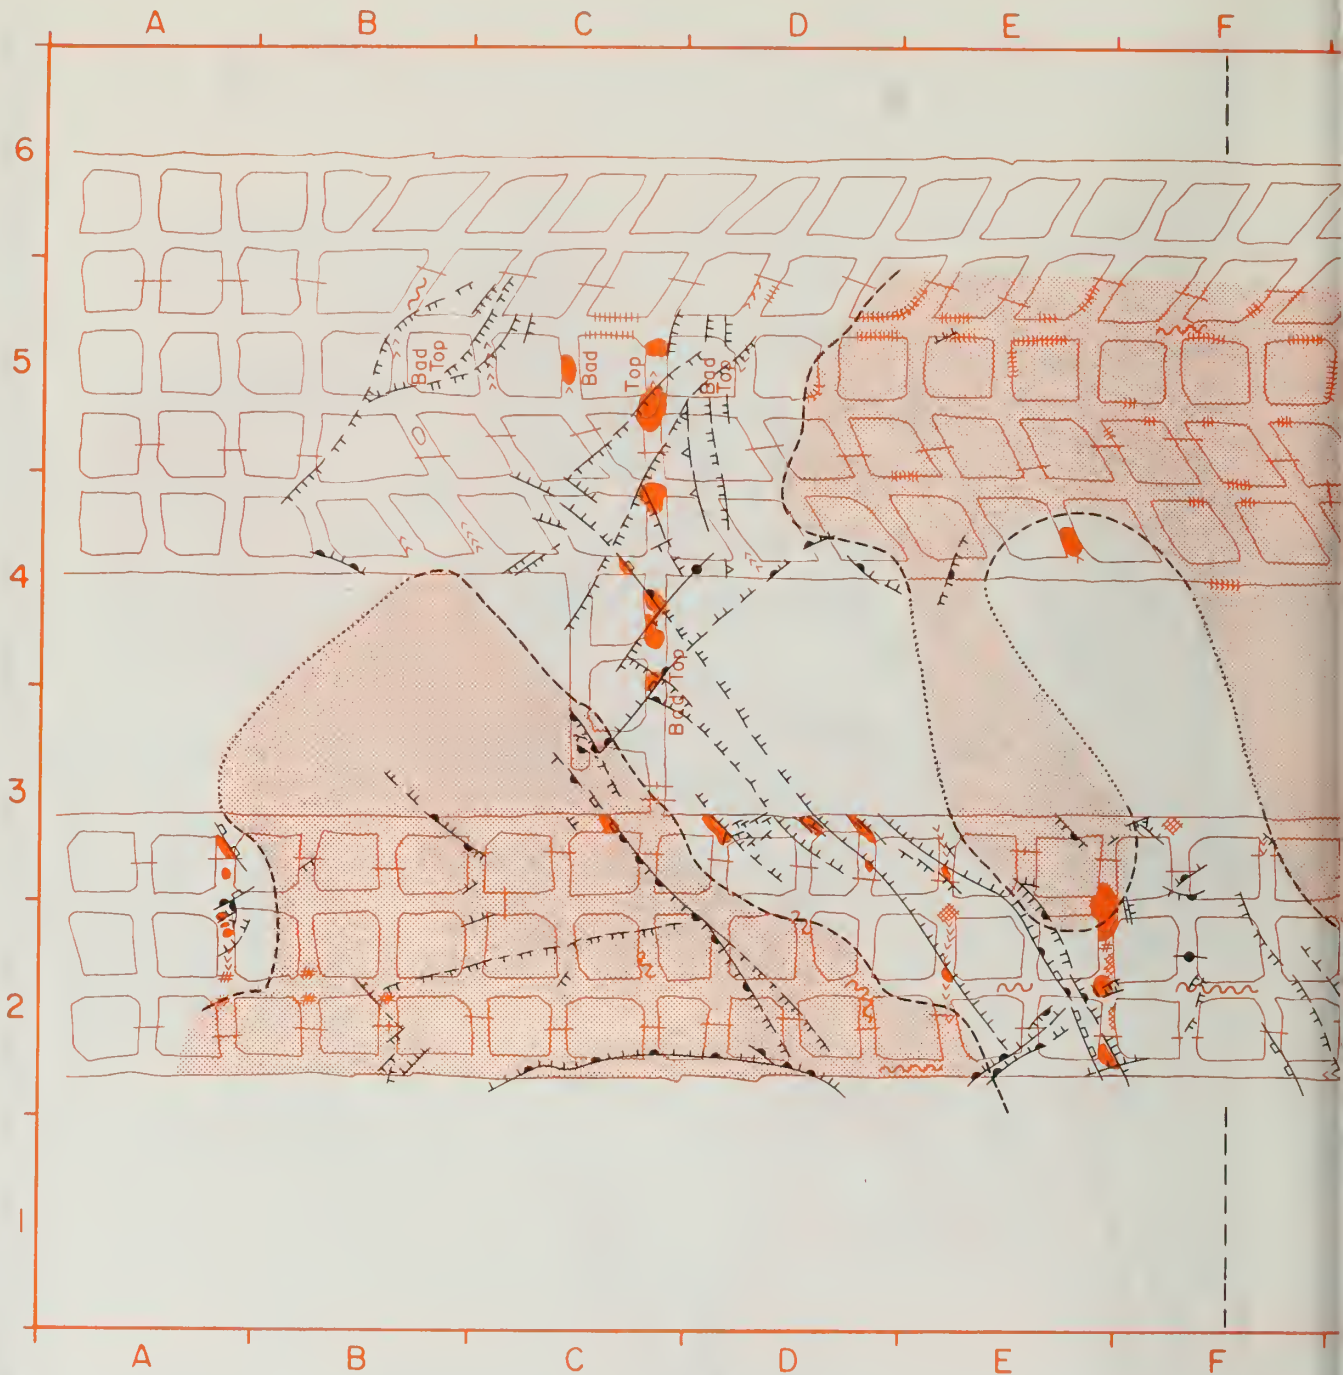
Figure C. Distribution of lithology, of clay-dike faults and clay dikes in the Herrin (No. 6) Coal and its immediate roof strata, and of roof falls and other induced instabilities in study area 3, mine A. (See also fig. 37, p. 34.)
